The Condominium at Homestead in Pickerington

Pickerington, OH • July 21, 2022

FULL RESERVE STUDY

Reference: 212312

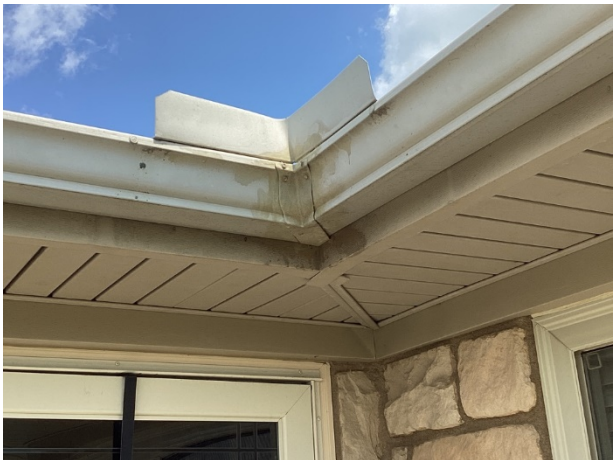
Condition: Condition varies with respect to age, with the 2018-2021 gutters and downspouts in good overall condition and the 2004-2009 gutters and downspouts in fair condition with typical leakage at seams and fastener rust and isolated downspout dents and detached downspout extensions evident

Evidence of leakage at seams

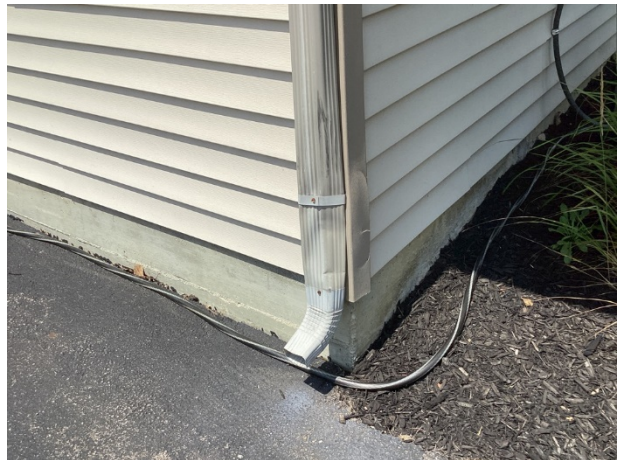
Downspout dents and fastener rust, shown at Unit 184

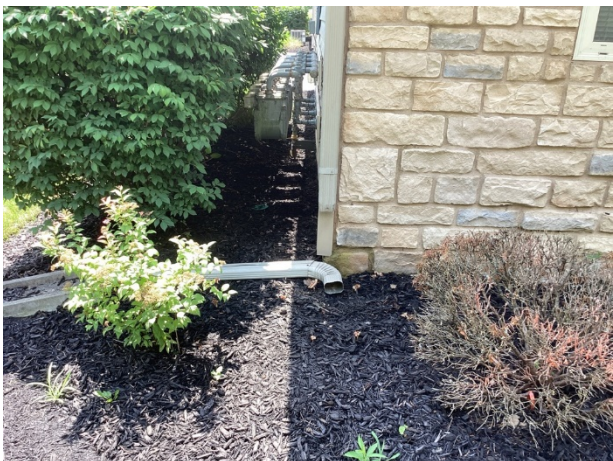
Detached downspout extension, shown at Unit 176

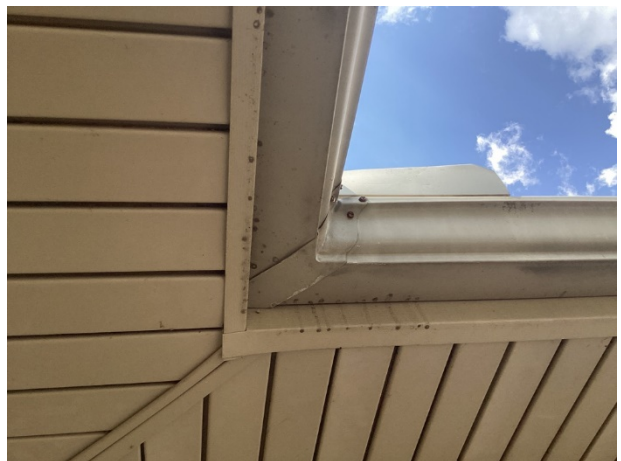
Evidence of water infiltration, shown at Unit 174

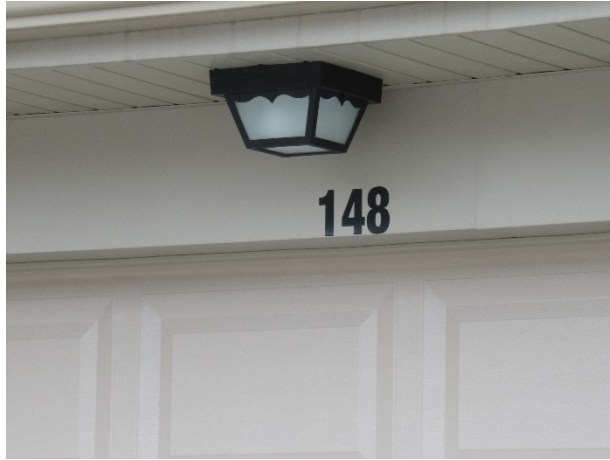
Condition: Good to fair overall with debris accumulation evident

Light fixture

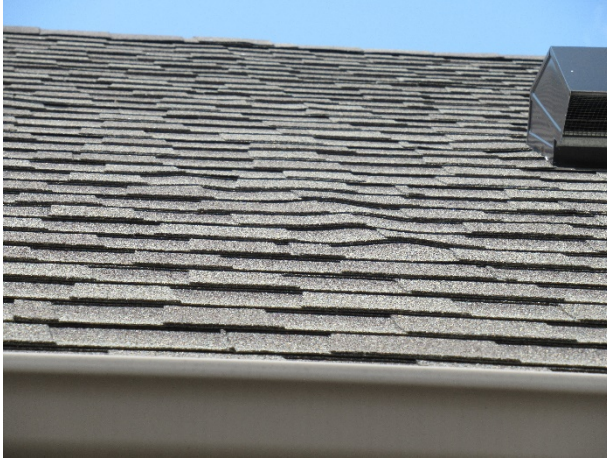
Condition: Good to fair overall with typical sheathing deflection, shingle lift and granular loss evident

Sheathing deflection

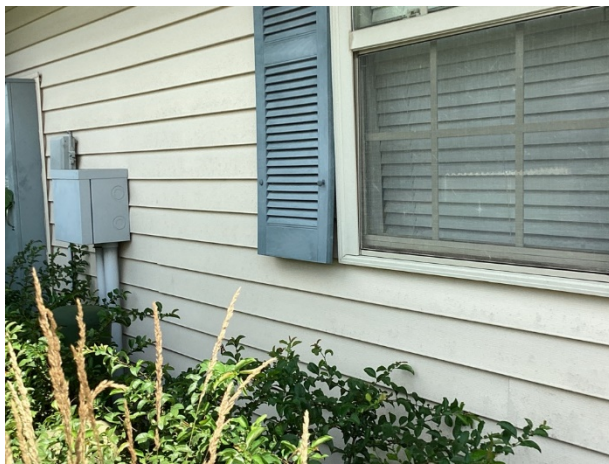
Condition: Good to fair overall with typical finish fade and isolated deflection evident

Finish fade and deflection, shown at Unit 212

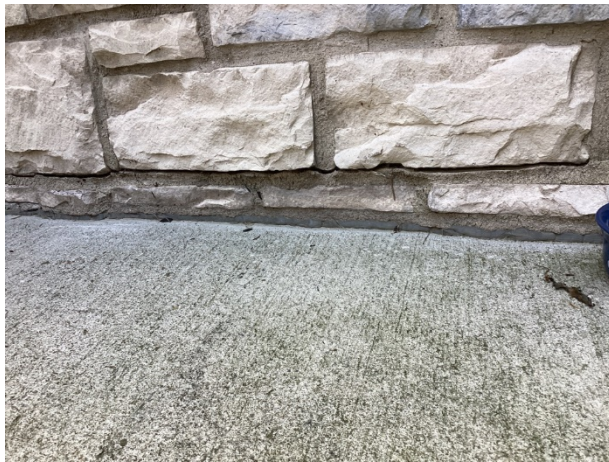
Condition: Varies; the masonry at the buildings is in good condition with isolated masonry cracks and mortar gaps. The masonry at the split rail fence pillars is in fair to poor condition with masonry cracks and damage evident.

Masonry crack, shown at Unit 240

Useful Life: The Association should anticipate inspection and repairs to the masonry veneer every 8- to 12-years.

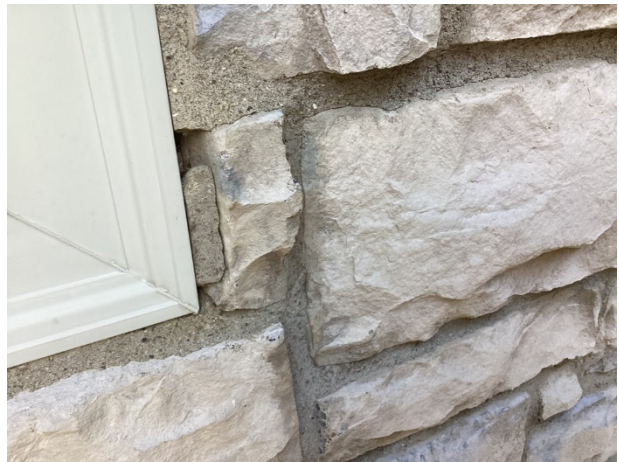
Mortar gap

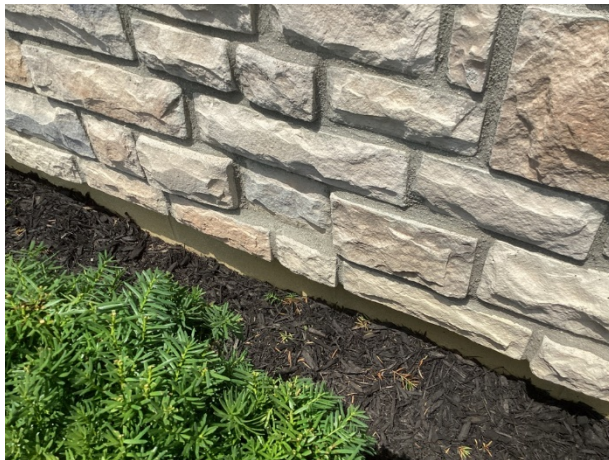
Apparent missing masonry

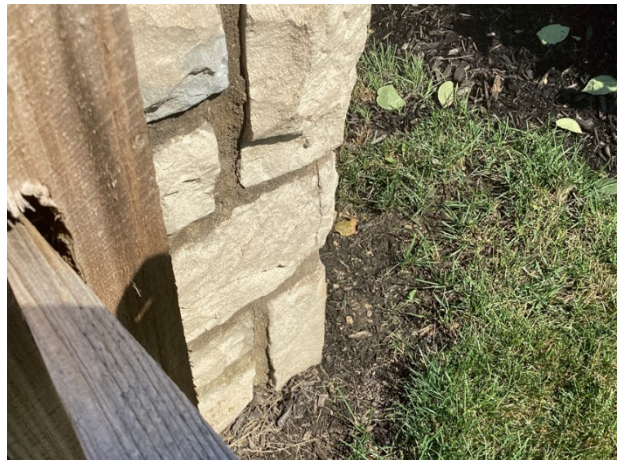
Masonry crack

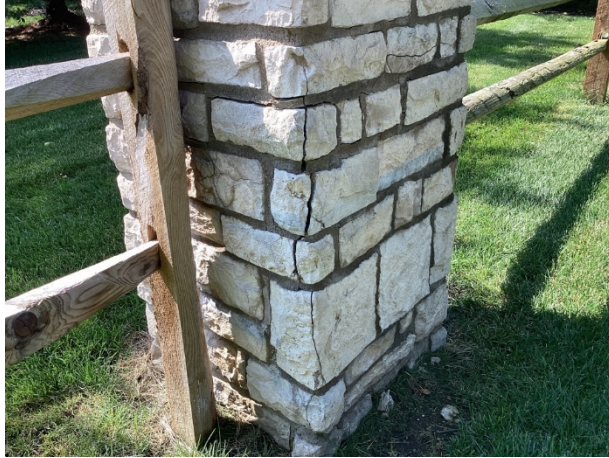
Masonry cracks

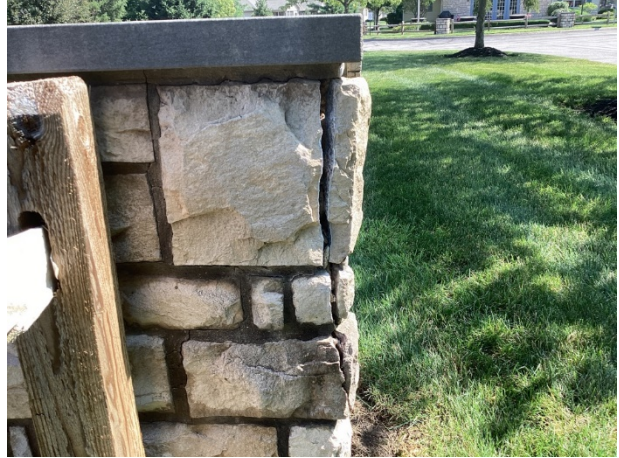
Significant masonry crack

- Repaving as deferral will result in dangerous road conditions and vehicle damage
- Repairs to the masonry pillars at the split rail fences

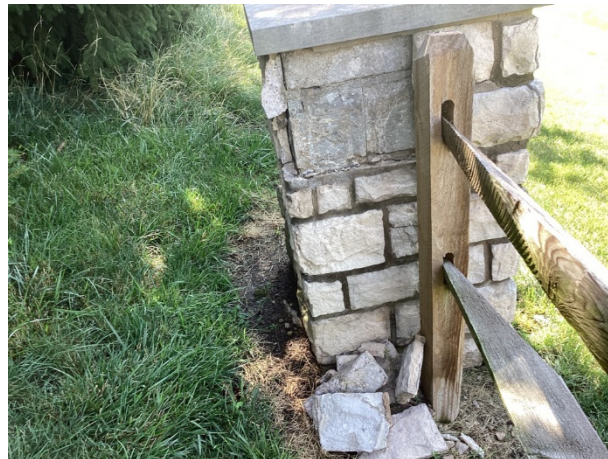
Significant masonry damage

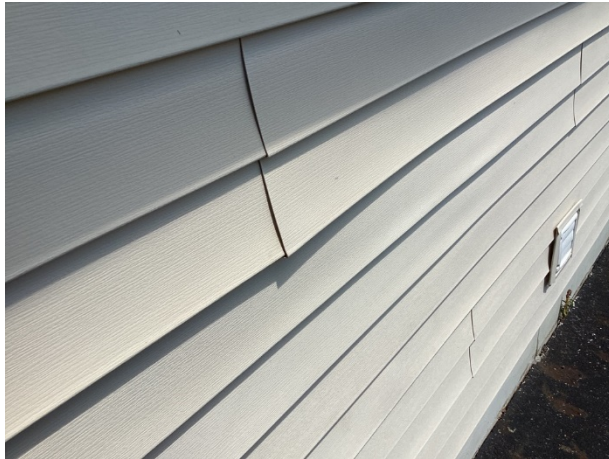
Condition: Good overall condition with isolated deflection and discoloration evident

Deflection, shown at Unit 192

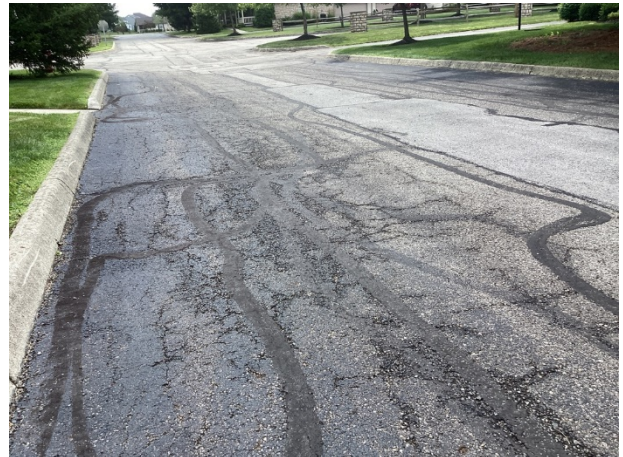
- **Phases One and Two, 2004-2007** – 10,750 square yards comprise the streets, access drives and parking areas and 3,200 square yards comprise the driveways. Fair to poor overall condition with typical surface deterioration, settlement, evidence of previous repairs and isolated potholes evident. The Association informs us of repairs conducted in 2020 due to a sinkhole by the entrance.
- **Phase Three, 2009** – 2,100 square yards comprise the streets, access drives and parking areas and 1,300 square yards comprise the driveways. Good to fair overall condition with cracks, settlement and previous repairs evident.
- **Phase Four, 2018** – 3,550 square yards comprise the streets and access drives and 850 square yards comprise the driveways. Good overall condition with isolated pavement cracks and previous repairs evident.

Surface deterioration and previous repairs

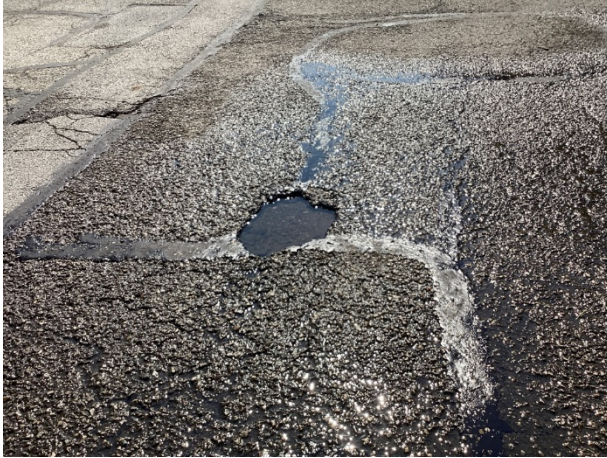
Pothole by entrance

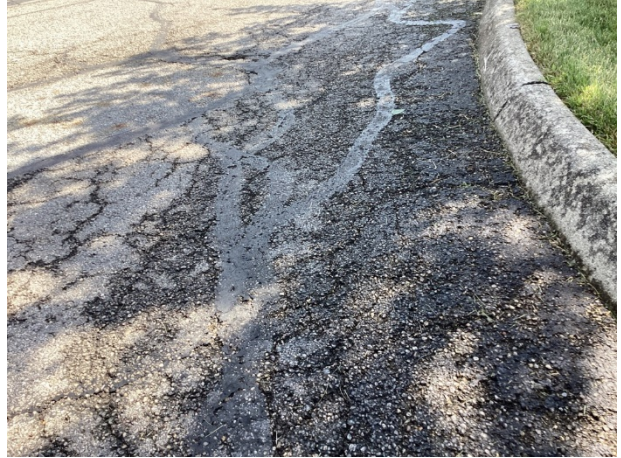
Surface deterioration by entrance

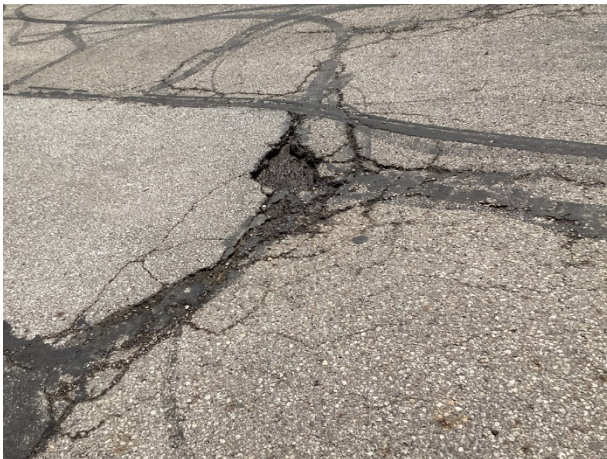
Pothole and surface deterioration

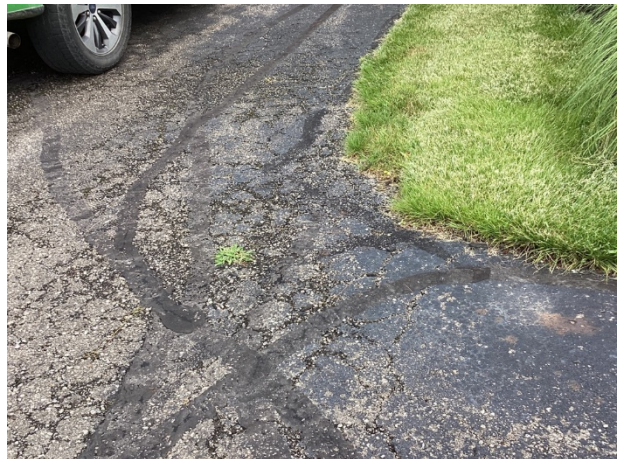
Surface deterioration

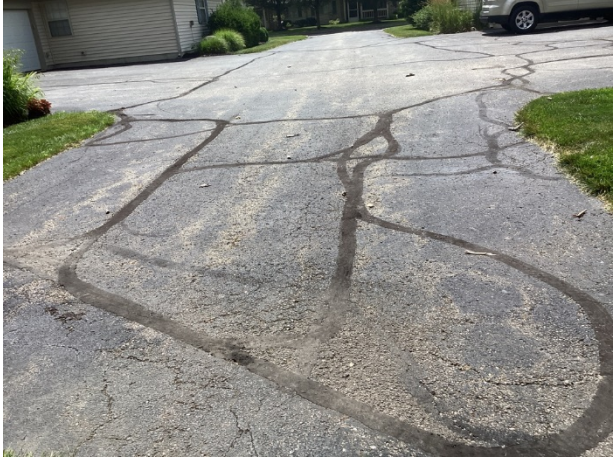
Phase One access drive overview, note settlement and surface deterioration

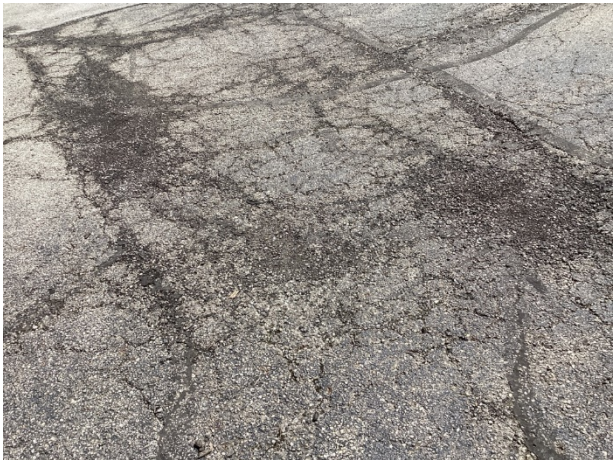
Surface deterioration

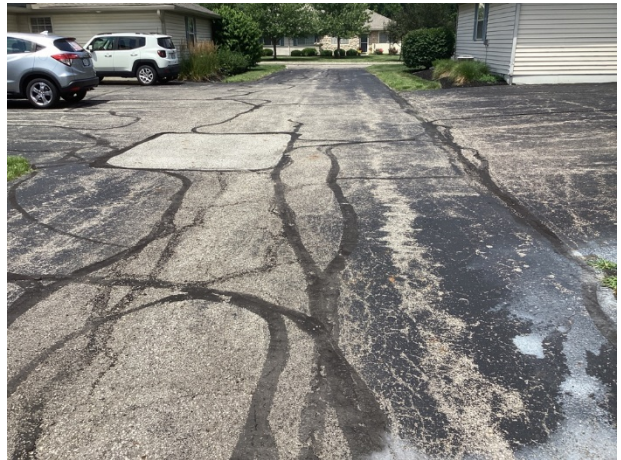
Phase Two access drive overview, note surface wear, previous patching and deterioration

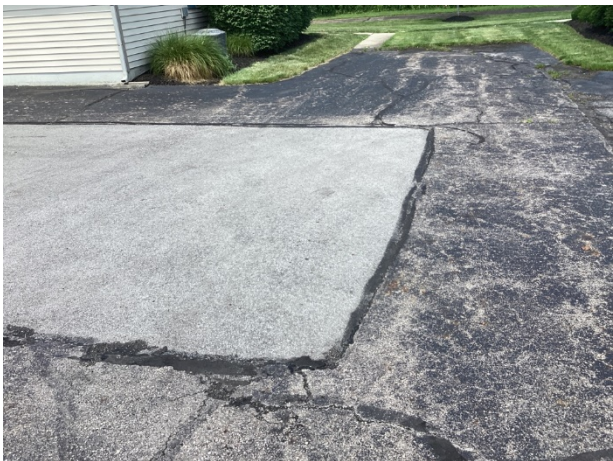
Settlement and previous patching at Phase Two access drive

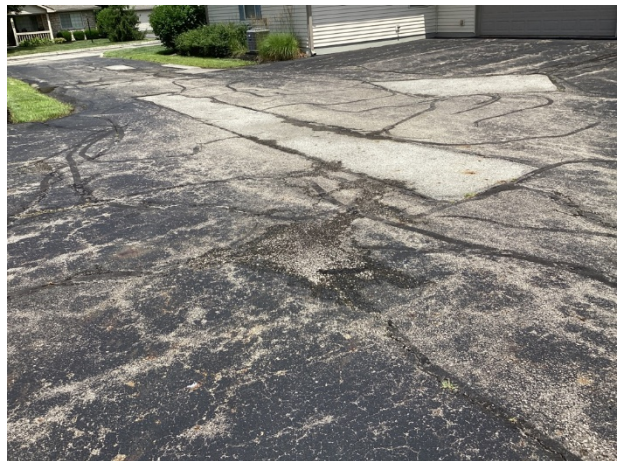
Phase Two access drive and driveway, note previous patching and deterioration

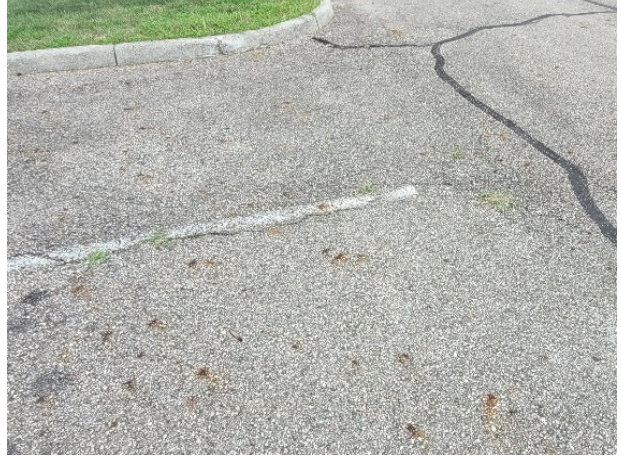
Settlement and pavement cracks

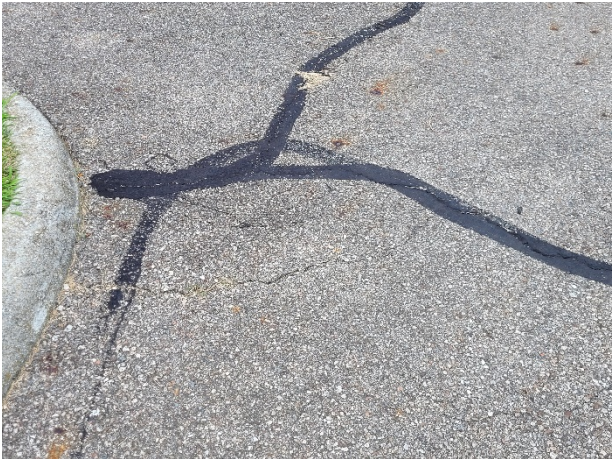
Settlement evident

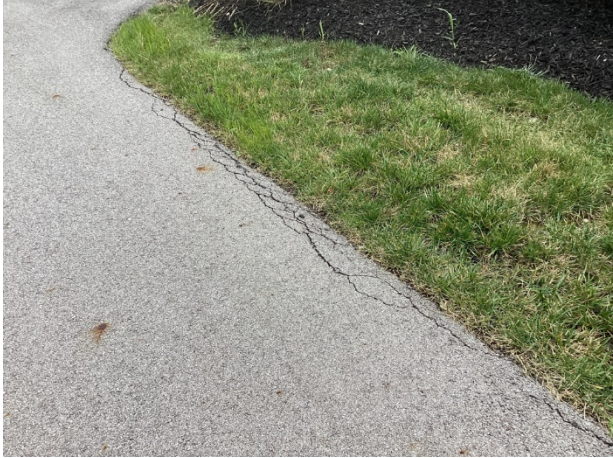
Edge cracks

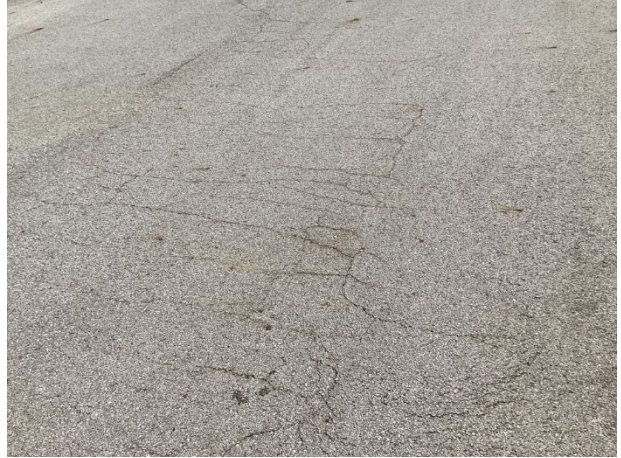
Pavement cracks

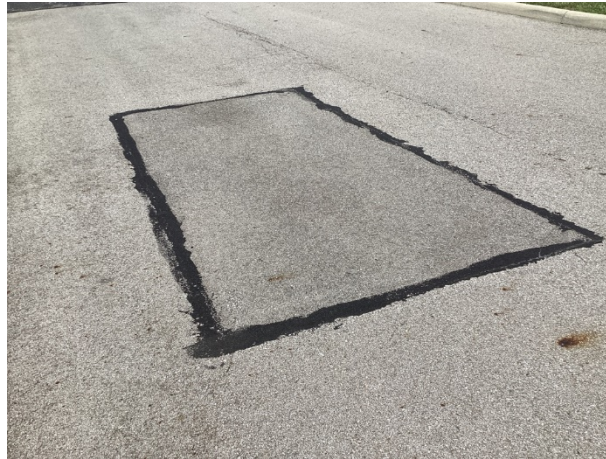
Previous patching repair

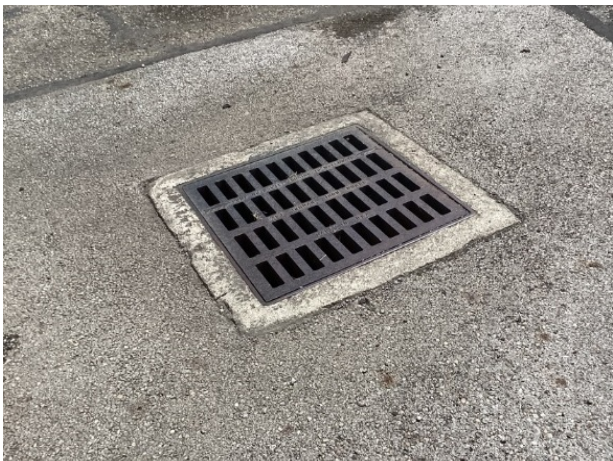
Condition: Good to fair overall with concrete deterioration and isolated damage evident

Catch basin, note deterioration

Useful Life: The useful life of catch basins is up to 65 years. However, achieving this useful life usually requires interim capital repairs or partial replacements every 15- to 20-years.

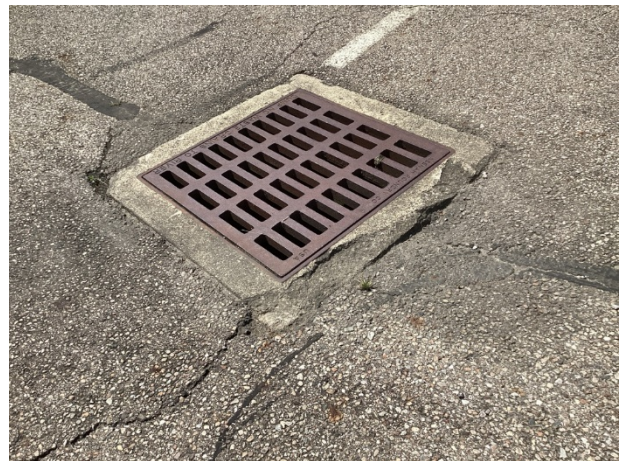
Concrete damage

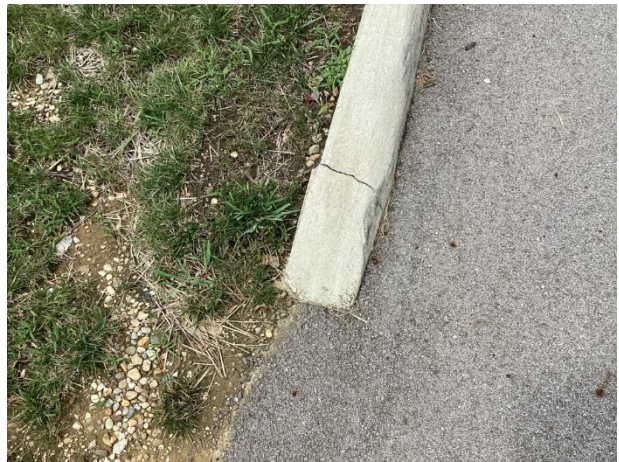
Condition: Good overall with isolated cracks evident

Concrete crack

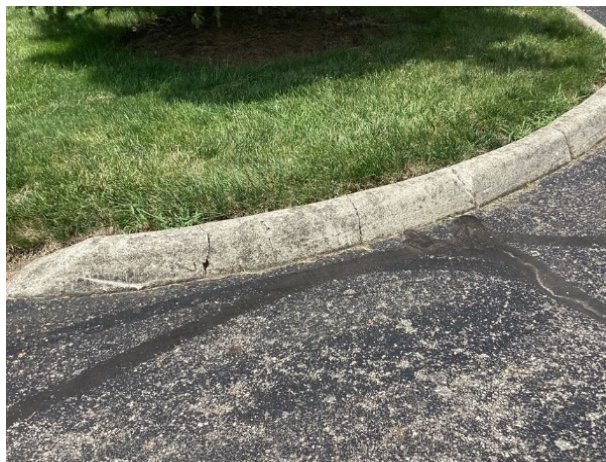
Concrete cracks

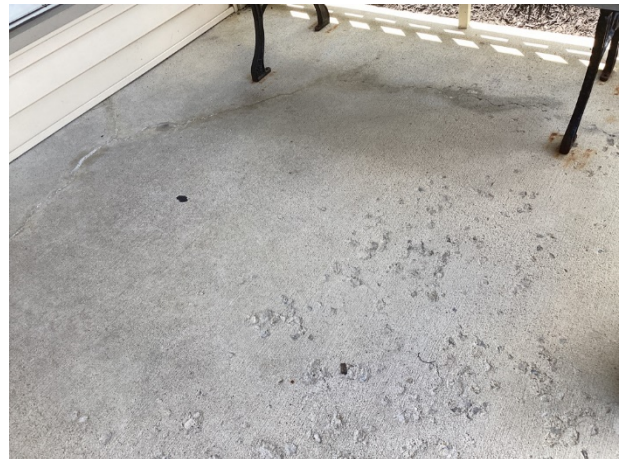
Concrete spall at mailbox enclosure

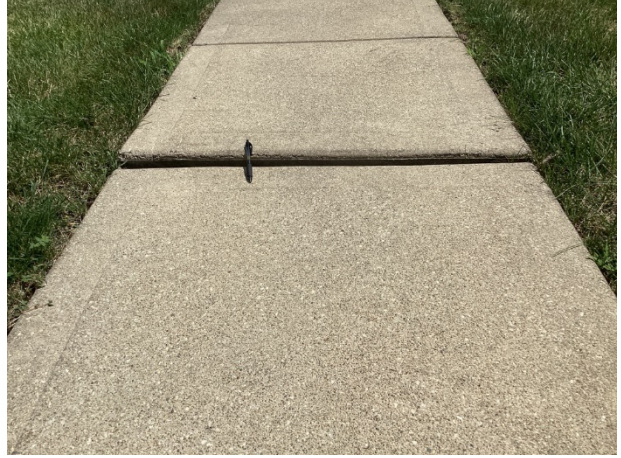
Trip hazard, shown by Unit 196

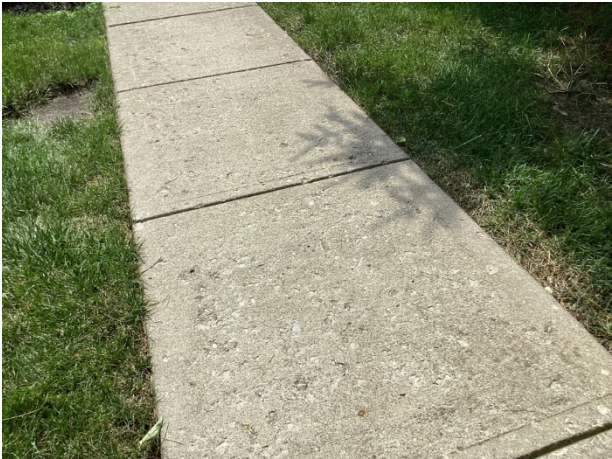
Sidewalk spall

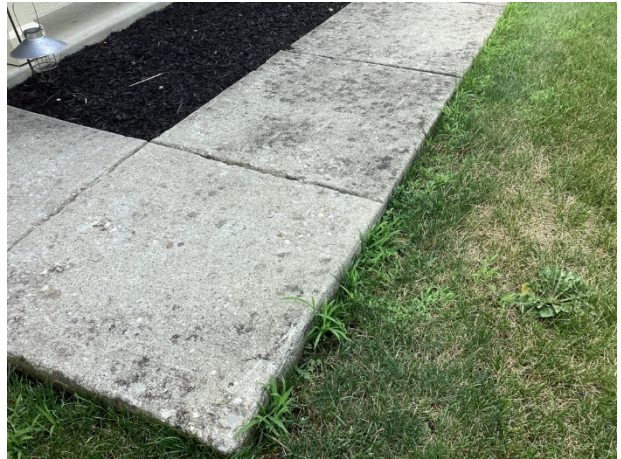
Concrete disintegration, shown by Unit 166

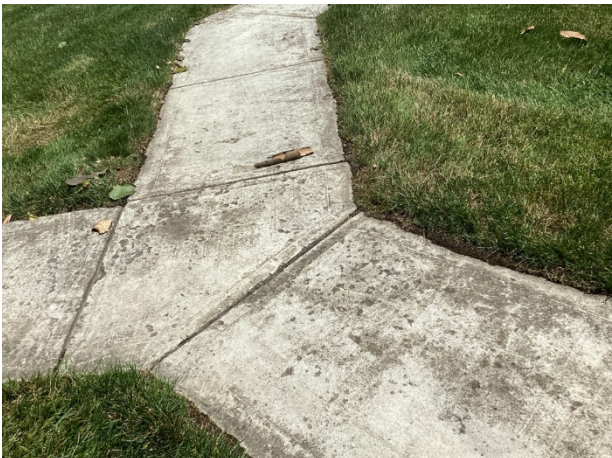
Surface deterioration

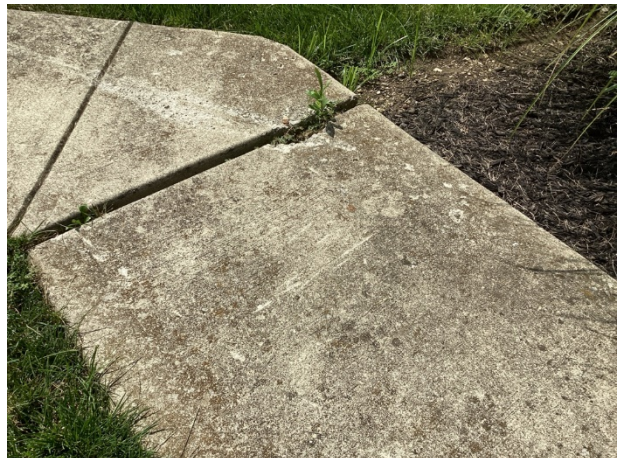
Concrete deterioration and organic growth

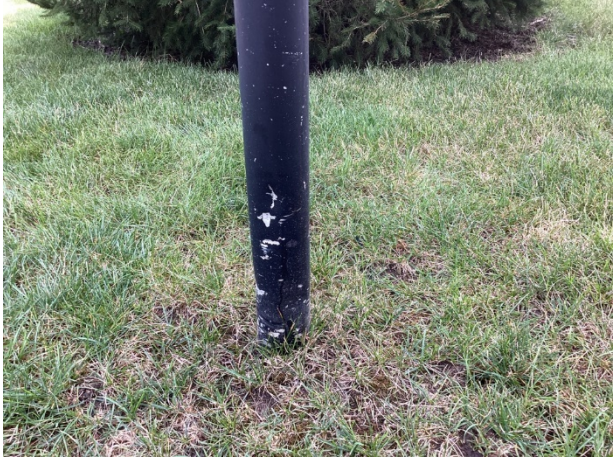
Condition: Fair overall with typical finish deterioration, finish fade, and isolated leaning light poles evident

Apparent landscape damage

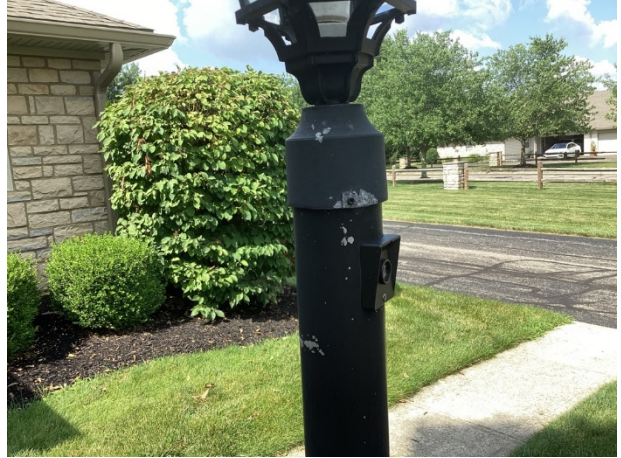
Finish deterioration

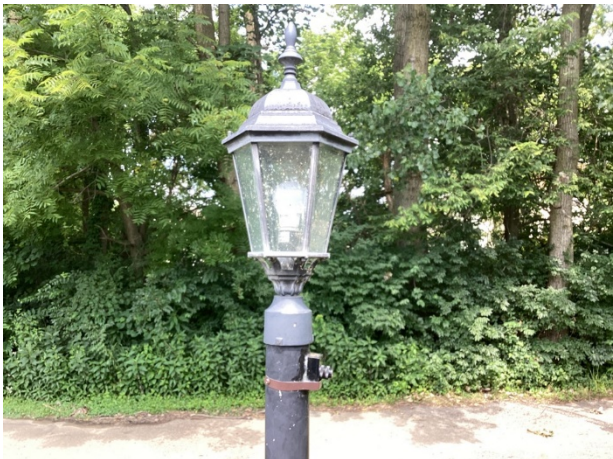
Finish fade and fastener rust

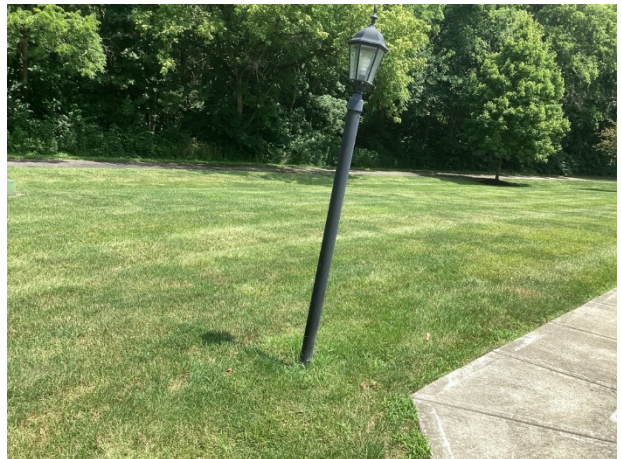
Leaning pole

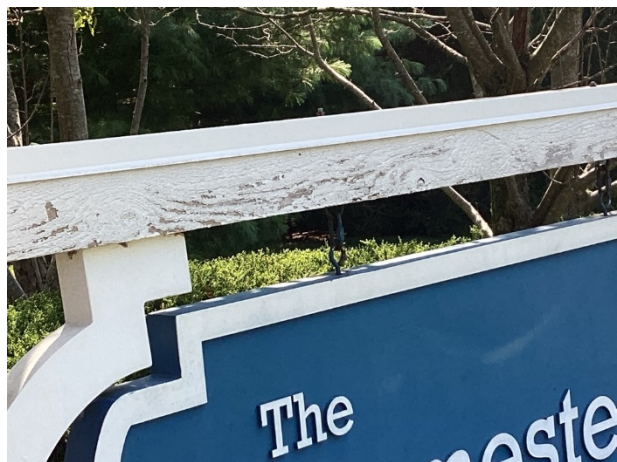
Condition: Good overall with finish deterioration evident

Paint finish deterioration

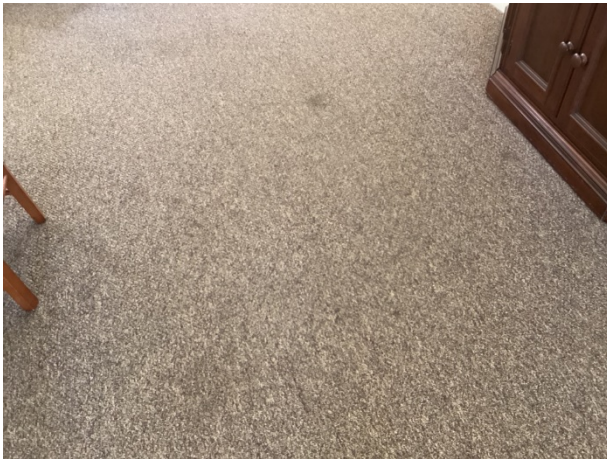
Carpet stains

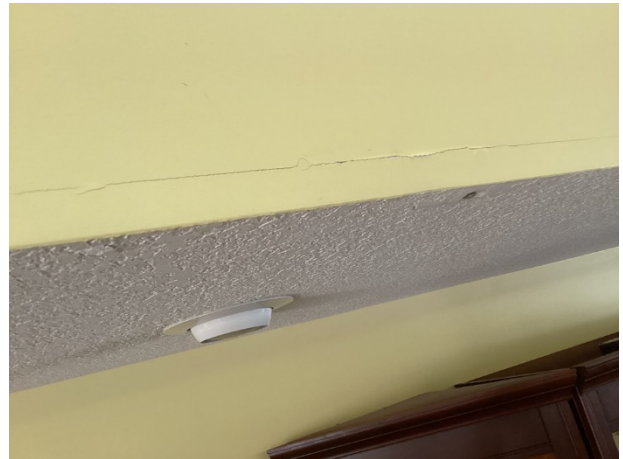
Finish crack

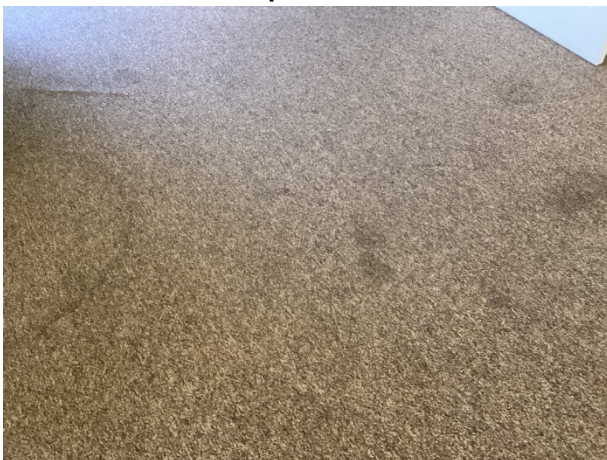
Carpet stains and seam line

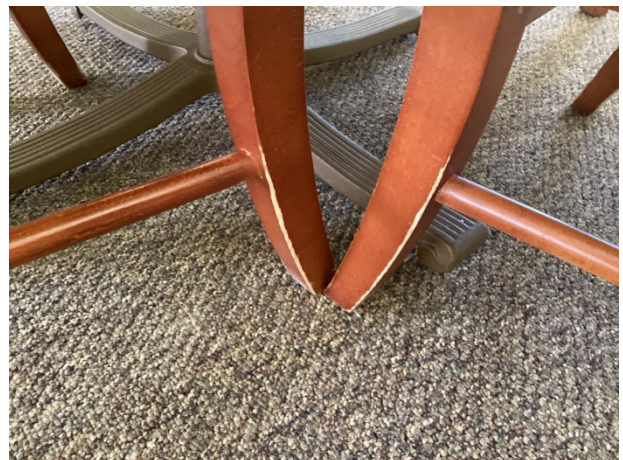
Finish loss at chair legs
