The Condominium at Homestead in Pickerington

Pickerington, OH • July 21, 2022

FULL RESERVE STUDY

Reference: 212312

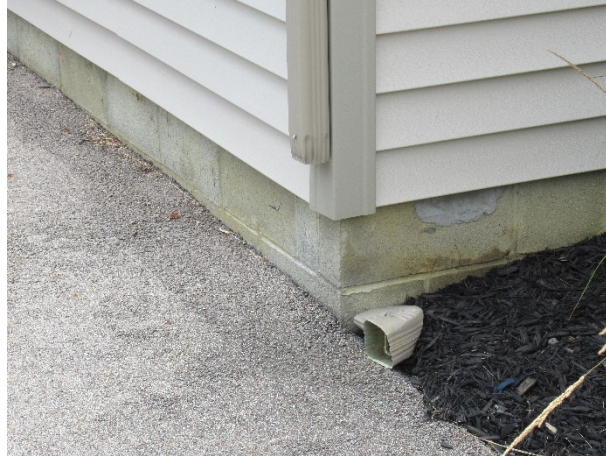
Detached downspout extension, show at Unit 138

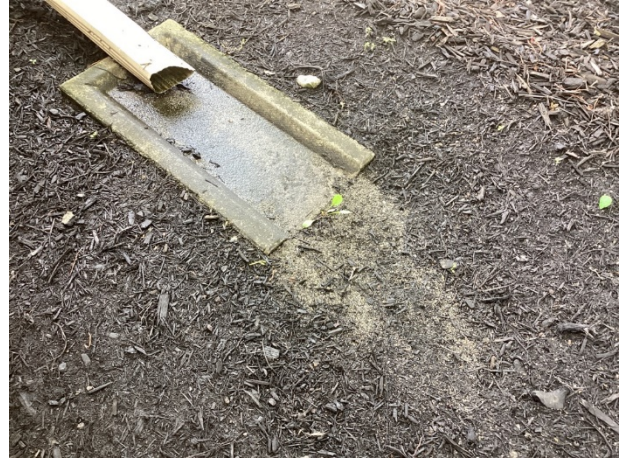
Granular loss

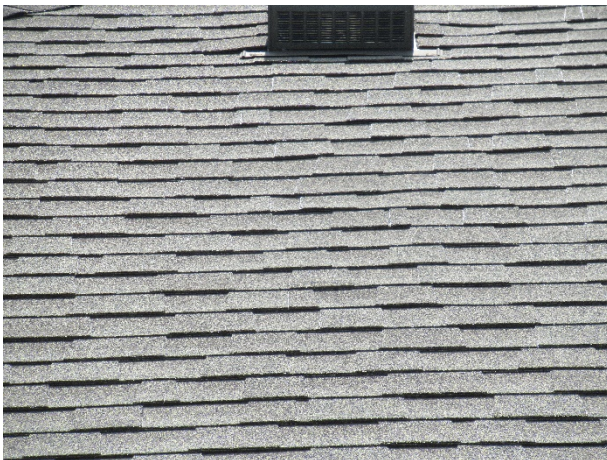
Apparent exposed fiberglass, shown at Building 1

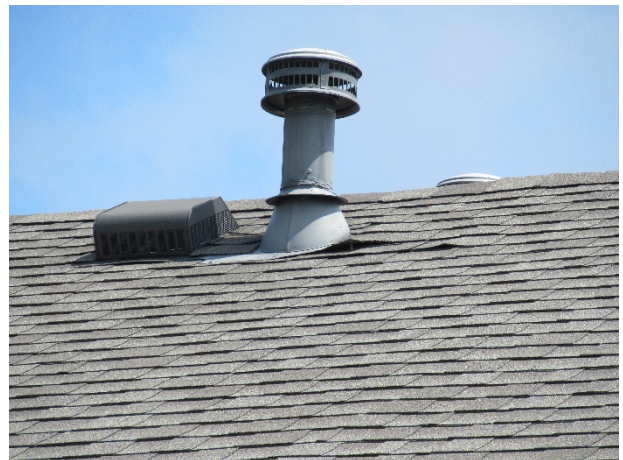
Shingle lift, shown at Building 4

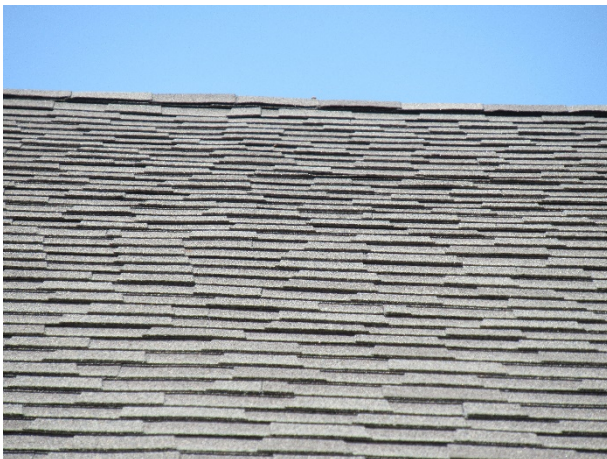
Sheathing deflection, shown at Building 4

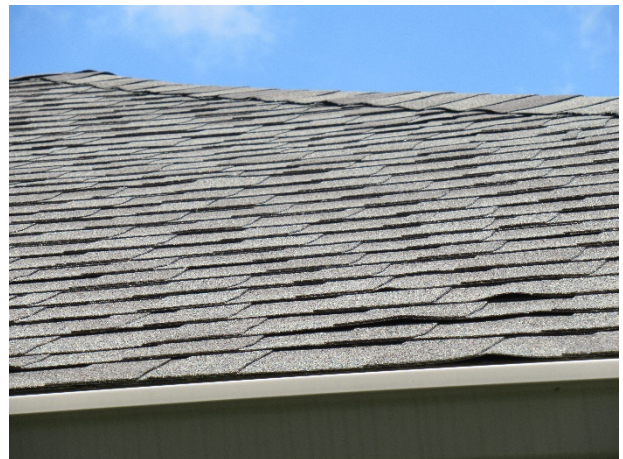
Shingle lift, shown at Building 6

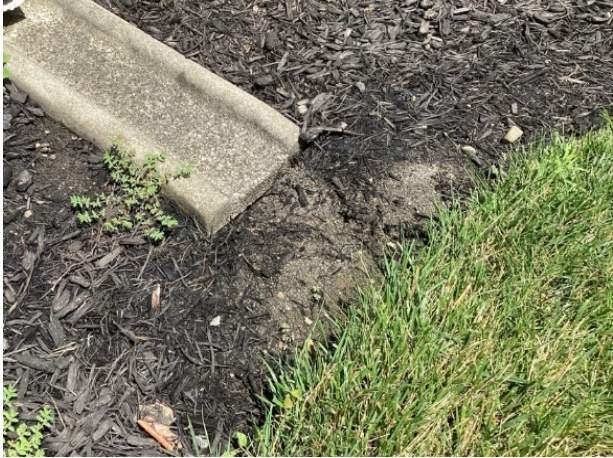
Granular loss, shown at Building 7

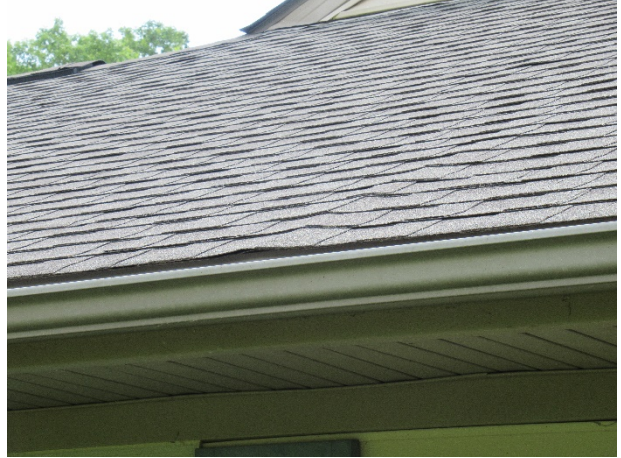
Sheathing deflection, shown at Building 19

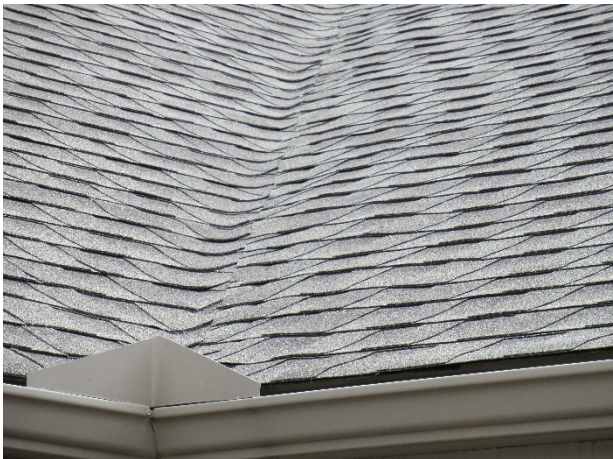
Minor sheathing deflection, shown at Building 19

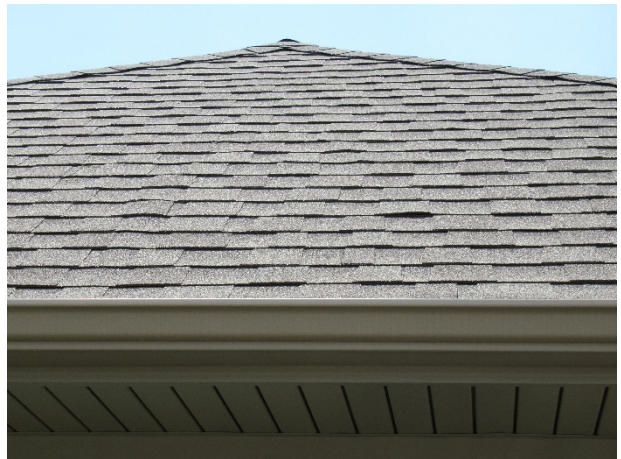
Shingle lift, shown at Building 20

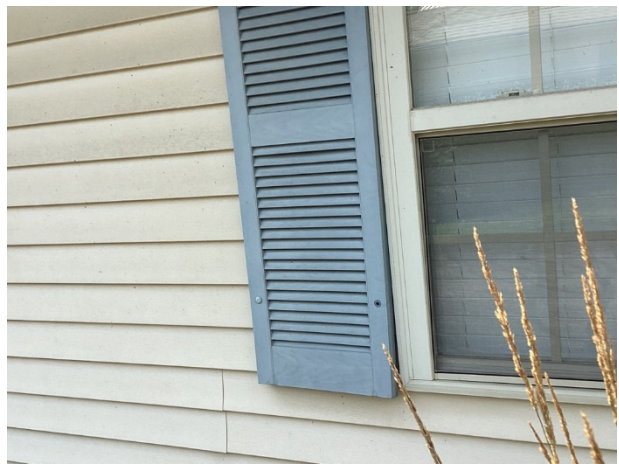
Finish fade and deflection, shown at Unit 182

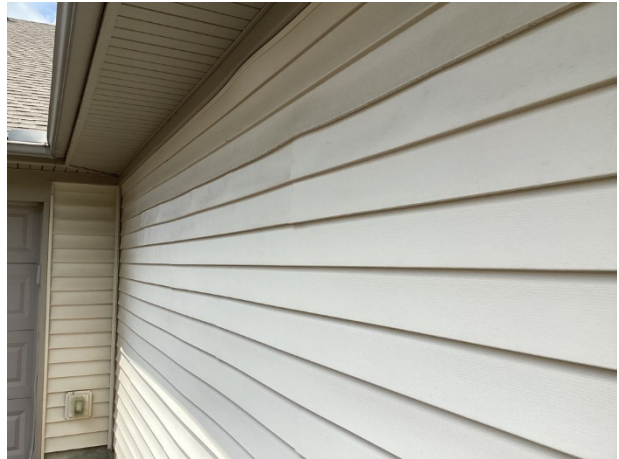
Deflection, shown at Unit 176

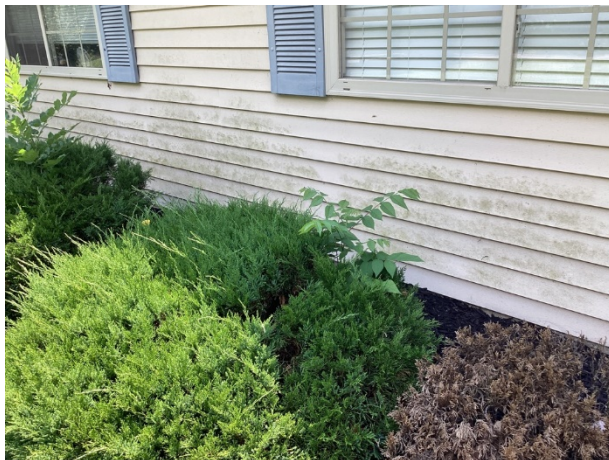
Finish discoloration

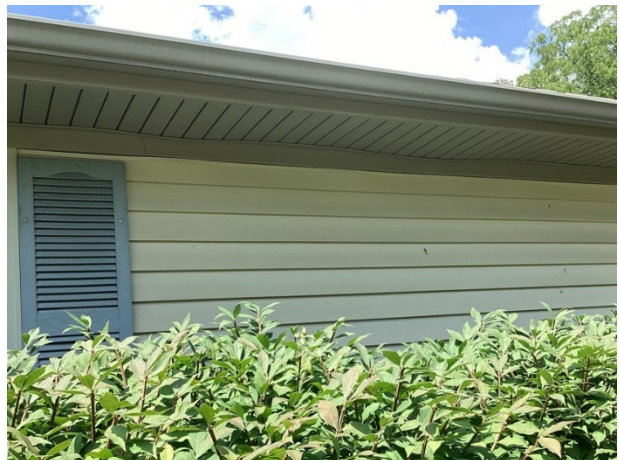
Soffit deflection

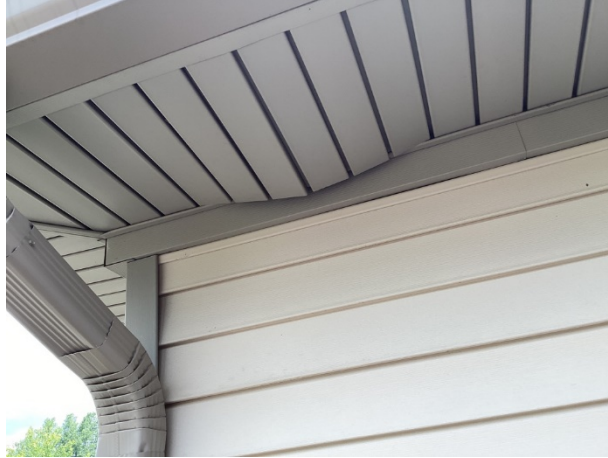
Soffit deflection, shown at Unit 102

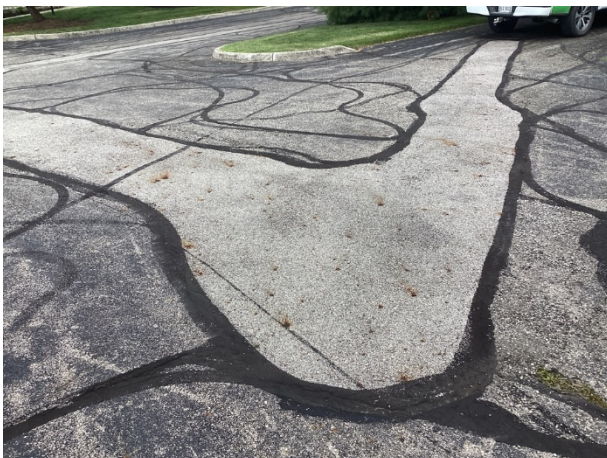
Previous patching and surface deterioration

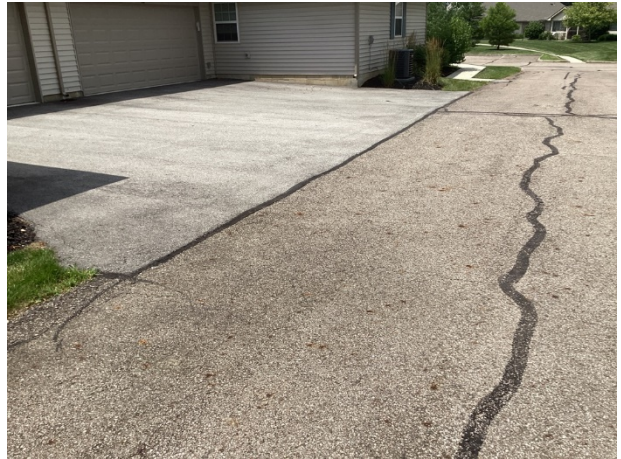
Phase Three access drive and Phase Four Driveway

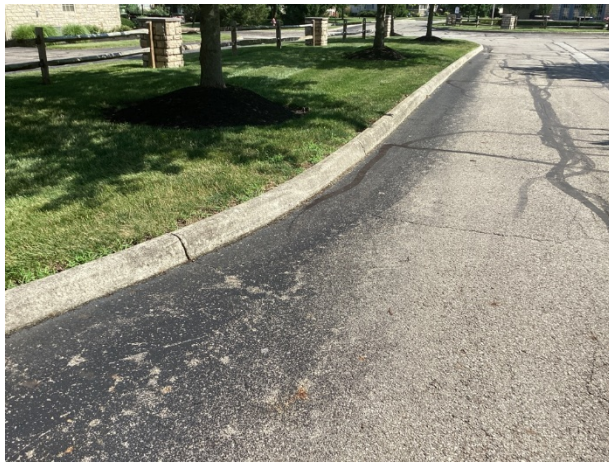
Condition: Good overall with isolated cracks evident

Concrete curb overview

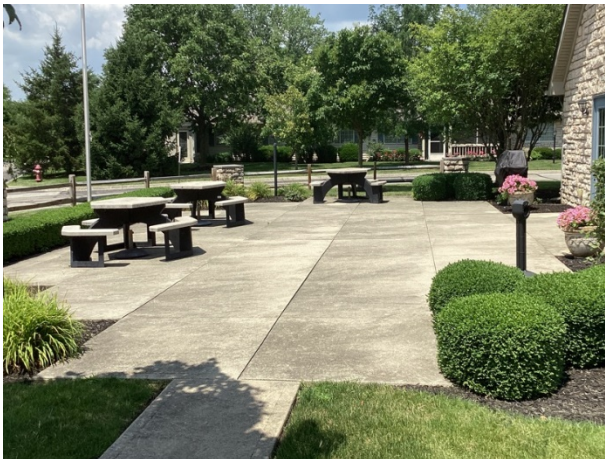
Condition and History: Good overall with spall, deterioration and isolated trip hazards evident; the Association has conducted concrete replacements and repairs on an as-needed basis.

Clubhouse concrete flatwork overview

- Annually:
 - Inspect and repair major cracks, spalls and trip hazards
 - Mark with orange safety paint prior to replacement or repair
 - Repair or perform concrete leveling in areas in immediate need of repair or possible safety hazard

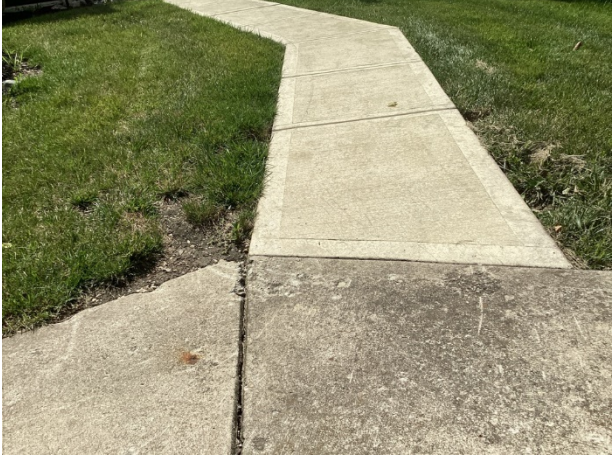
Recently replaced sidewalk section

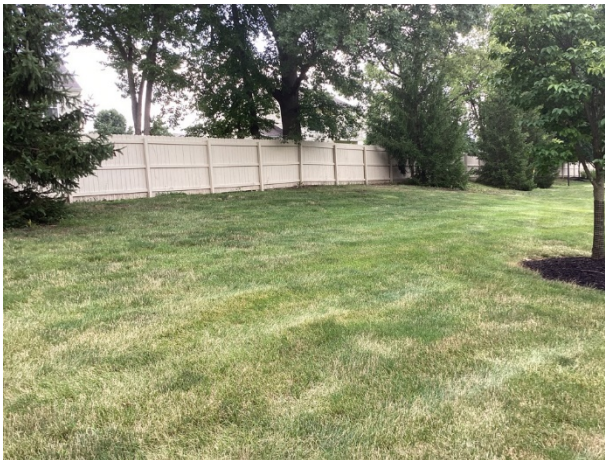
Condition: Good overall with isolated split wood components evident

Wood fence overview

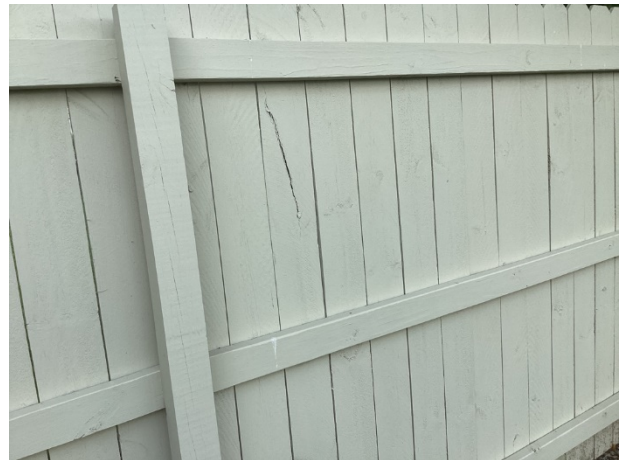
Wood splitting

- Annually:
 - Inspect and repair loose sections, finish deterioration and damage
 - Repair leaning sections and clear vegetation from fence areas which could cause damage

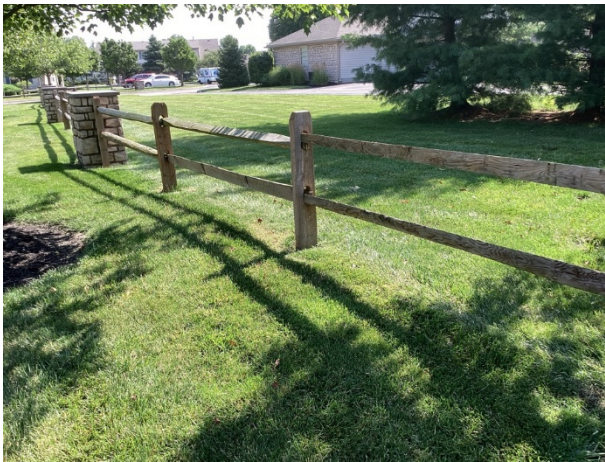
Condition: Good overall

Split rail fence overview

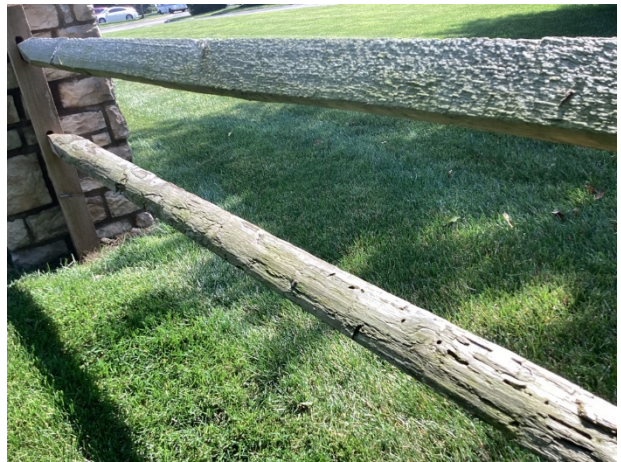
Split rail detail

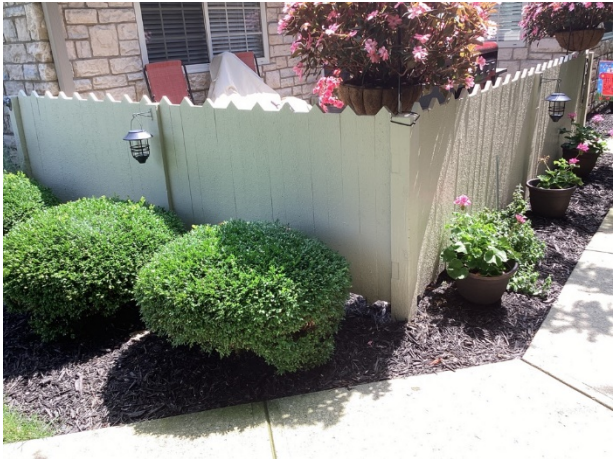
Condition: Good overall

Unit fence overview

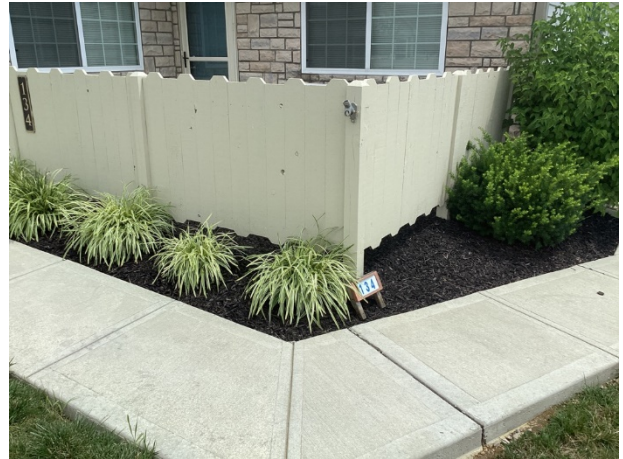
Unit fence overview

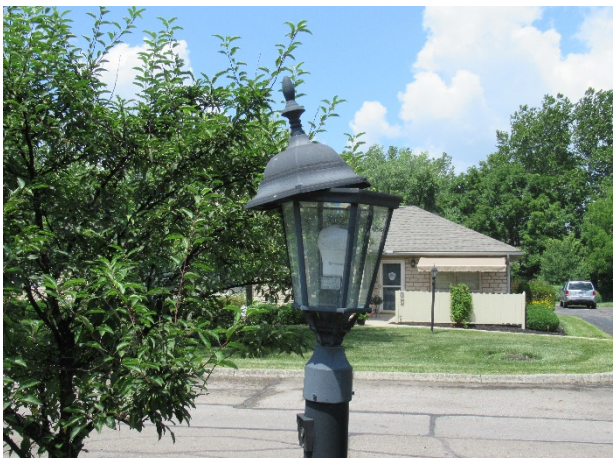
Detached fixture cap

- As-needed:
 - Inspect and repair broken or dislodged fixtures, and leaning or damaged poles
 - Replaced burned out bulbs as needed

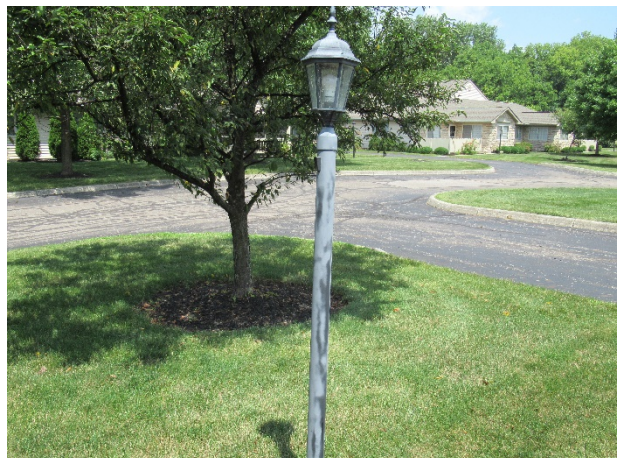
Condition: Fair overall with typical finish deterioration, finish fade, and isolated leaning light poles evident

Finish fade and minor lean

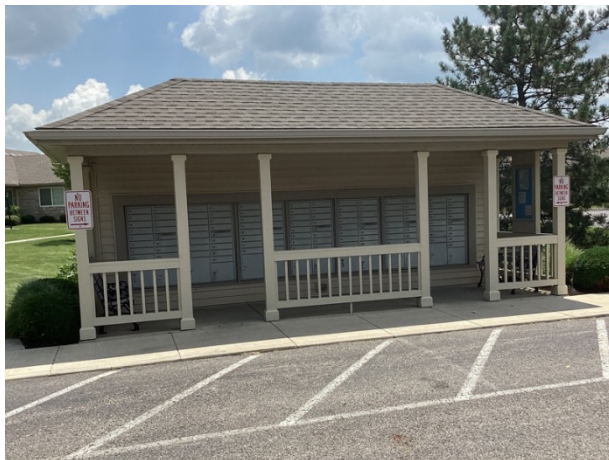
Condition: Good overall

Mailbox enclosure

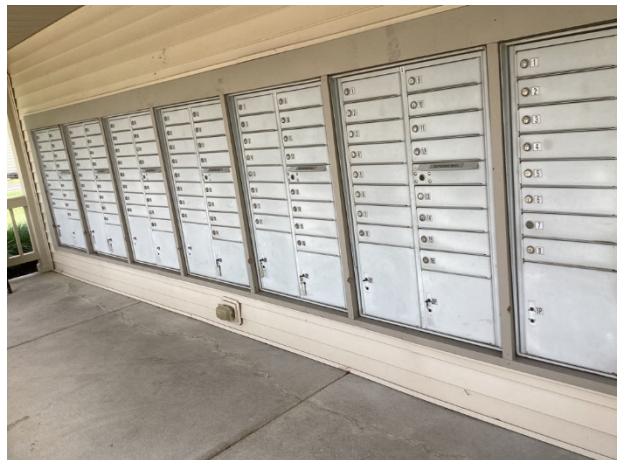
Mailboxes

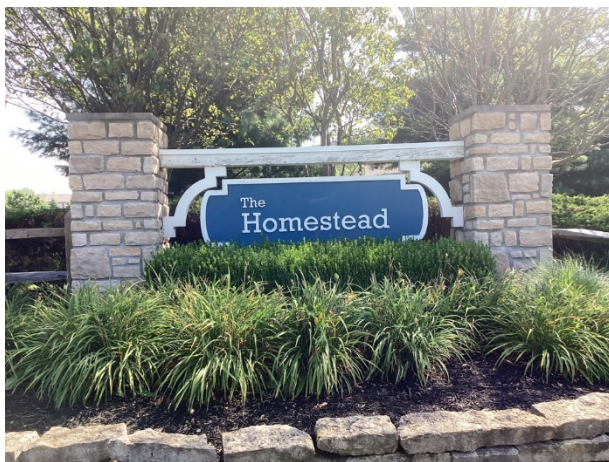
Condition: Good overall with finish deterioration evident

Monument signage overview

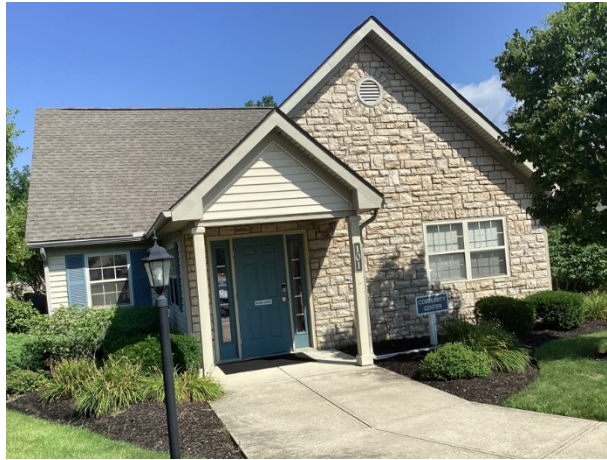
Clubhouse overview

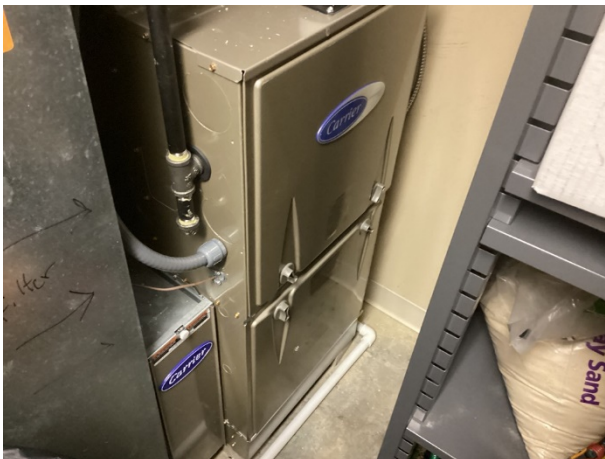
Condition: Reported satisfactory

Furnace

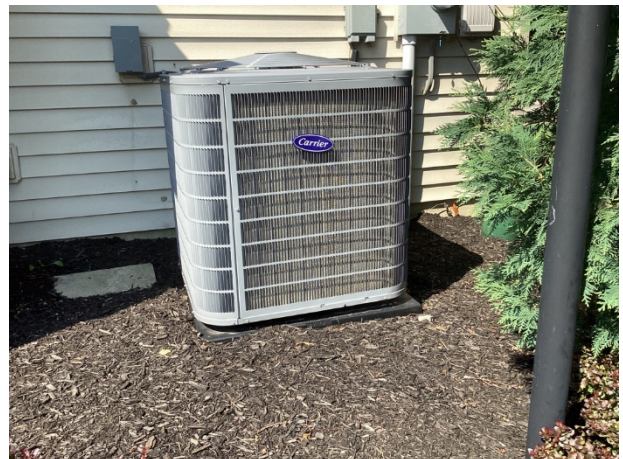
Condensing unit

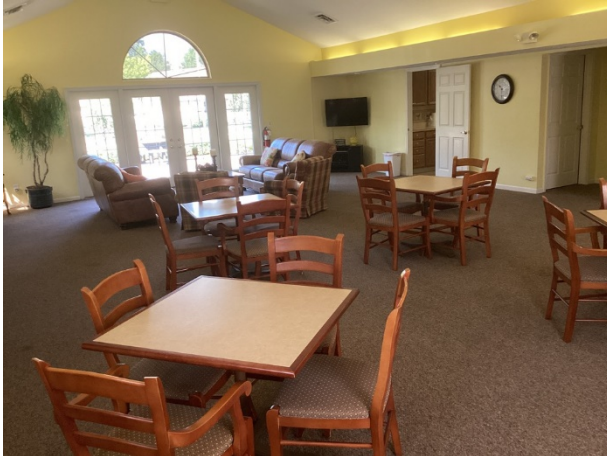
Condition: Fair overall with carpet stains, visible seams, paint finish cracks and minor furniture damage evident

Clubhouse interior overview

- Application of paint finishes and carpet replacement
- Replacement of up to fifty percent (50%) of the furnishings

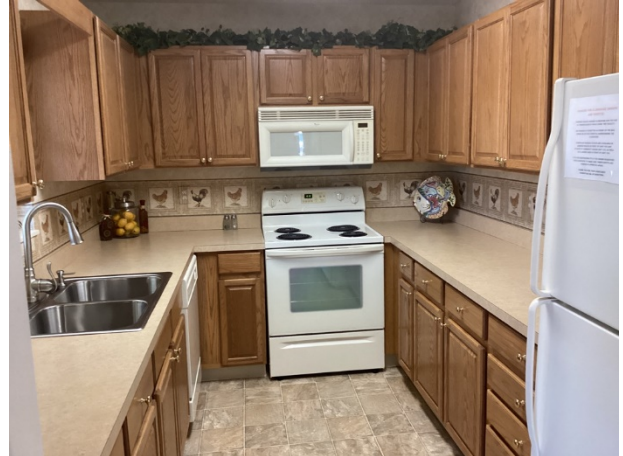
Kitchen overview

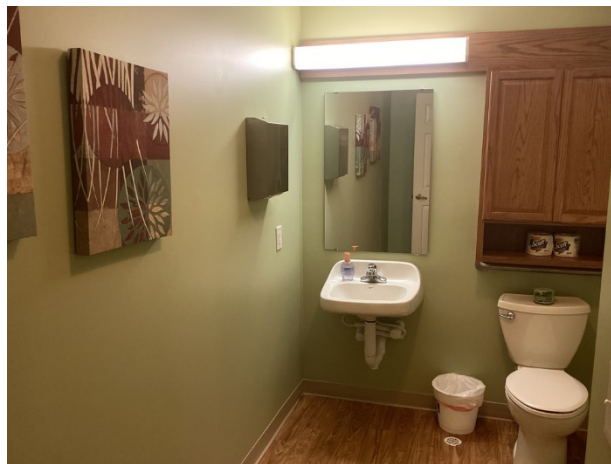
Condition: Good overall with no significant deterioration evident.

Restroom overview

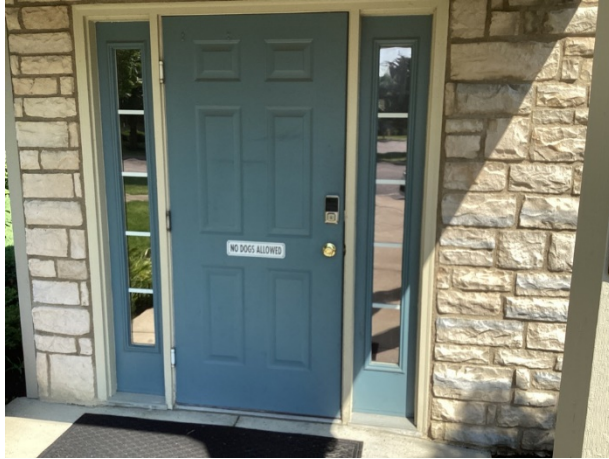
Clubhouse entrance door

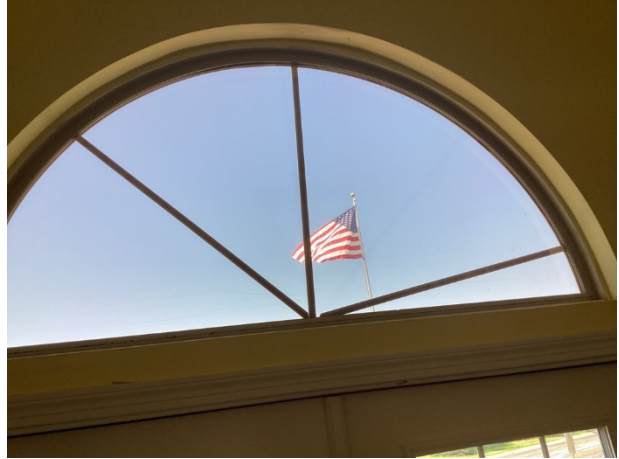
Condition: Good overall with isolated fallen mullion

Clubhouse window, note fallen mullion
